## Faecal Sludge Management and Latrine Pit Sludge Levels in Rural Households in Prey Veng Province, Cambodia (3 of 4)

Phalla Chem, IV Bunthoeun, Soon Sekheng, Kim Hor, James Harper

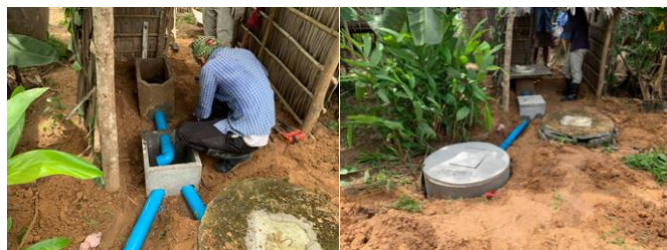
Figure 2: Upgrading a single-pit latrine to an alternating dual-pit latrine

One household's existing single-pit latrine was upgraded to an alternating dual-pit latrine while the EMWF team was on-site. The household agreed to pay the mason 150,000 Riel to upgrade their latrine. The masons first removed the slab pan, chamber box, back wall, and door, and then dug a new pit 0.80 m deep and 0.60 m away from the old pit. Two concrete rings (0.50 m high, 0.80 m inner diameter) were then placed in the new pit, and the chamber box was then cleaned with water. The upgrade required two hours, and the EMWF team recorded the upgrade on video (available upon request). All

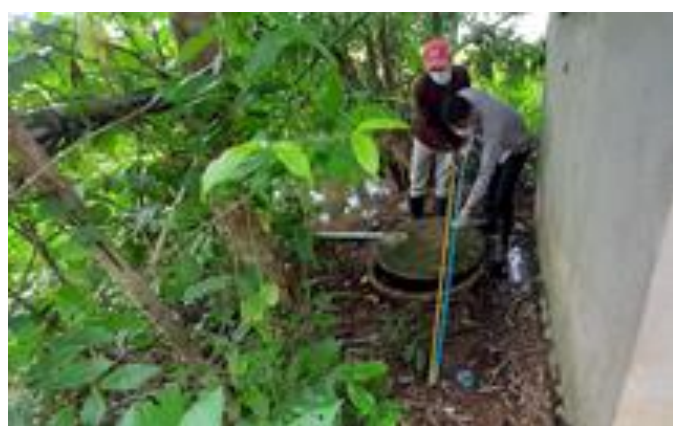
Figure 3: Measuring if a second pit can fit next to the existing pit to create an alternating dual-pit latrine

The masons that were on site also noted that one household's latrine appeared difficult to upgrade due to 1) insufficient space around the existing pit, and 2) the latrine shelter and floor being made of brick, making them difficult to move. The masons thus recommended building a new alternating dual-pit latrine in a different location near the house.

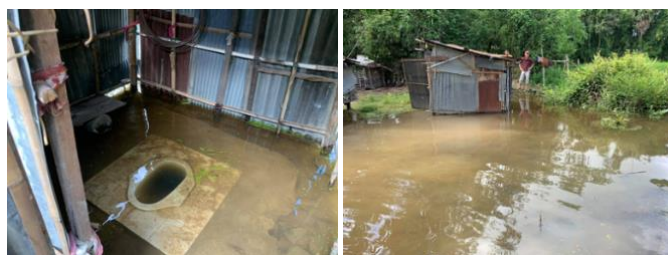
Figure 4: Flooding at one household that prevented its members from accessing or using their latrine

Due to flooding, one household's members could not access or use their latrine. While their latrine was flooded, they used a relative's latrine that is approximately 70 meters away. All members typically use their own latrine when it is not flooded. Flooding typically occurs at this household from early September to late November. During the next study in December, the EMWF team and masons will explain and discuss options with this household regarding upgrading and improving the location of their latrine to ensure that it would be accessible

1. Encourage latrine installers to strongly consider the effects of site selection when constructing a new latrine or upgrading a single-pit latrine to an alternating dual-pit latrine. Flooding can be present only in specific areas on a given property; thus, latrines should be placed on areas of high ground when possible.

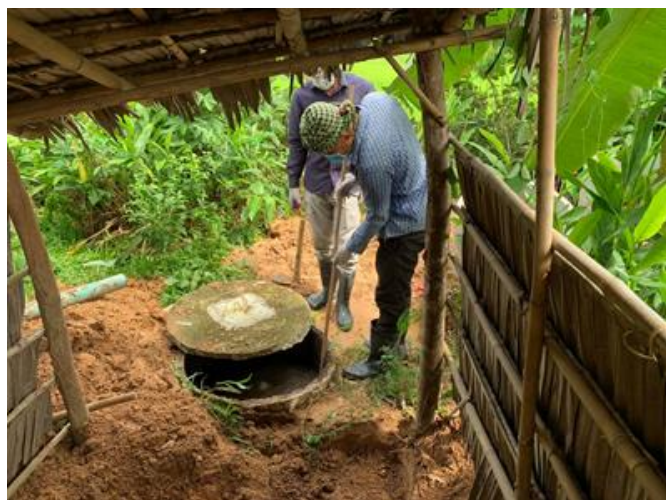
Figure 5: Measuring the sludge level within a pit

Pit sludge depths ranged from 0.35 to 1.45 m, leaving emptying capacities ranging from 0.05 to 1.15 m. These variations in sludge levels were likely due to households having different numbers of members and hosting events with varying numbers of guests.

Over the three months since the last study, pit sludge depths increased between 0.01 and 0.30 m at three households and remained constant at one household. The pit that showed the smallest increase in sludge depth (0.01 m) had been partially emptied 12 days prior to this study.
